Infrastructure Projects Southern Home Safe

The Southern Region's Weekly Safety Update

13 June 2018

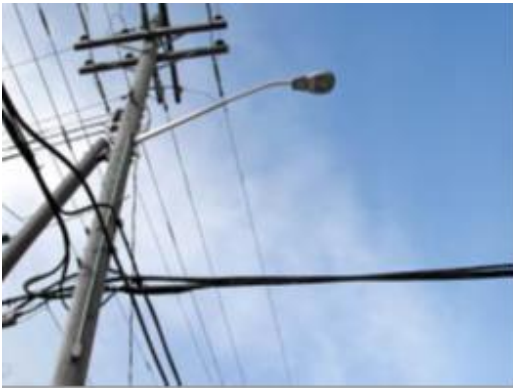
A construction site contractor was fined over £500,000 for striking an overhead power line. The driver was emptying a load of soil from the tipper when he drove forward with the bed still raised and touched the 33kV overhead power lines. The tipper truck sustained minor damaged; however, the driver was unhurt.

The HSE said that the company should have carried out a 'more rigorous' risk assessment and that its system of work was inadequate to reduce the risk of tipper trucks striking overhead power lines.

- Always identify the risk of potential contact with overhead cables from the outset.
- Ensure that adequate measures are taken to prevent contact.
- If overhead lines cannot be diverted prior to works commencing, goalposts should be erected either side of them to warn all drivers of their presence.

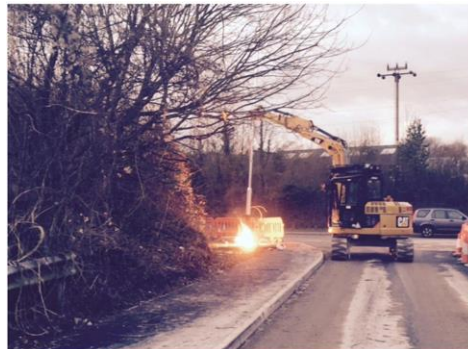
In 2015, the site team in Basingstoke was placing lighting columns into previously installed sleeves. They proceeded to install the final column of the day with the base of the final eight metre lighting column.

The excavator operator then began to lift the column guided by the foreman/banksman so that the base of the column could be slid into the sleeve. As the column was moved towards the vertical position, it came into contact with SSE 11kV overhead cables located directly above the sleeve. This resulted in the ground worker, who was holding the base of the lighting column, receiving an electric shock and contact/exit burns.
